## TEST REPORT

**Report No.:** E0632.01-301-47

CR LAURENCE CO., INC.  
Los Angeles, California

**PRODUCT TYPE:** Awning (Projected Out)  
**SERIES/MODEL:** 7200

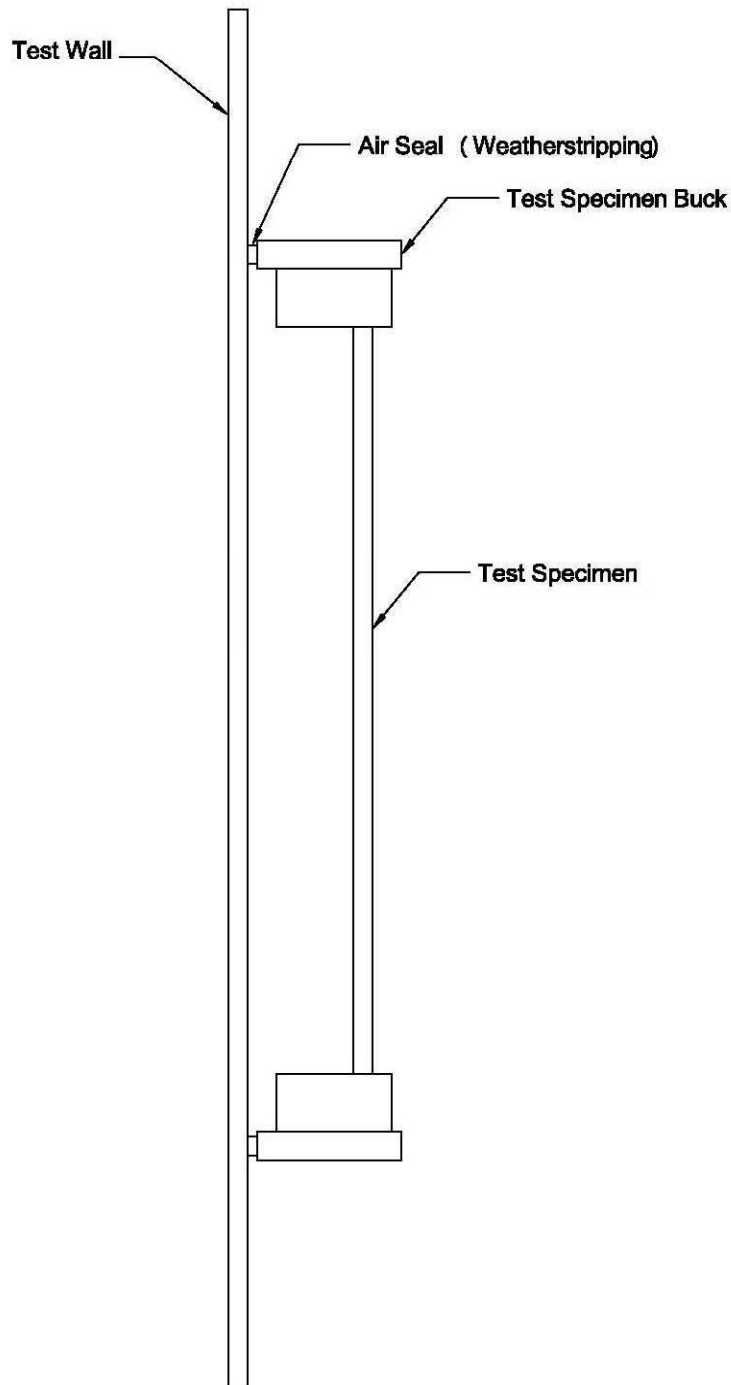
### Appendix B

**Location of Air Seal:** The air seal between the test specimen and the test wall is detailed below. The seal is made of foam weatherstripping and is attached to the edge of the test specimen buck. The test specimen buck is placed against the test wall and clamped in place, compressing the weatherstripping and creating a seal.
